NASA TN D-6519

CORROSION STUDY OF BARE AND COATED STAINLESS STEEL

by J. D. Morrison

John F. Kennedy Space Center

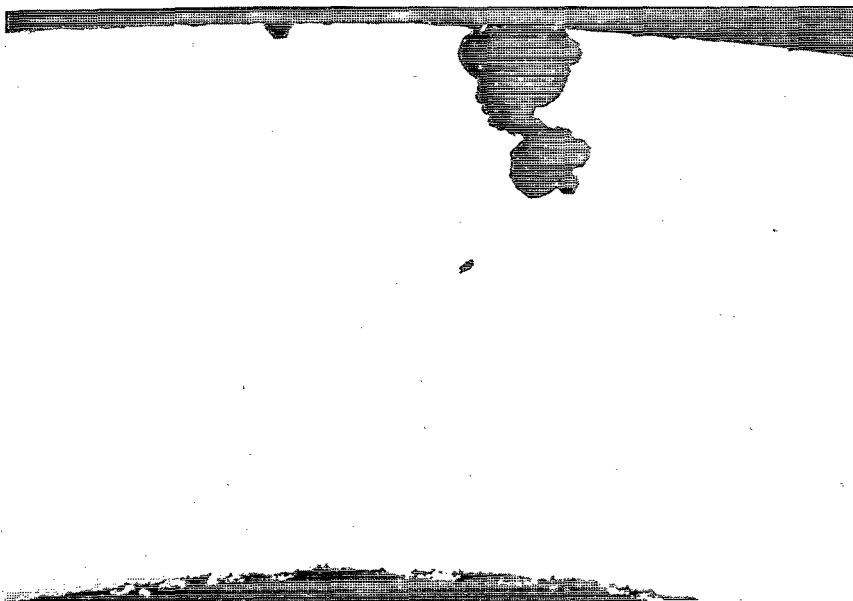
Figure 12. Surface Characteristics and Pit Depth of Type 304L Exposure Sample

VIEW A Magnification: 2X
Exposed Portion

VIEW B Magnification: 2X
Sheltered Portion

VIEW C Magnification: 80X
Cross-Section of Tubing Wall in Deepest Pit Area

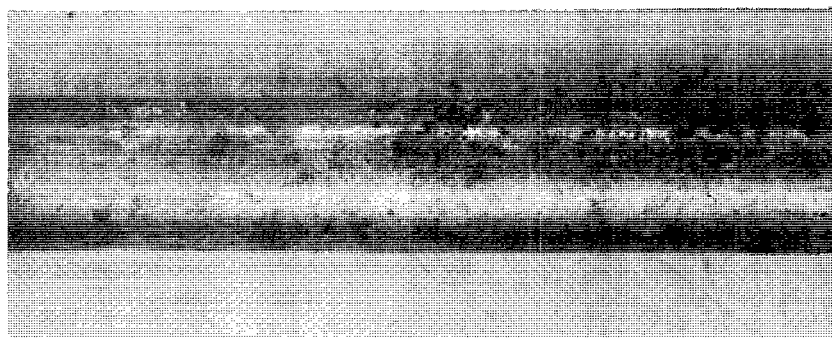
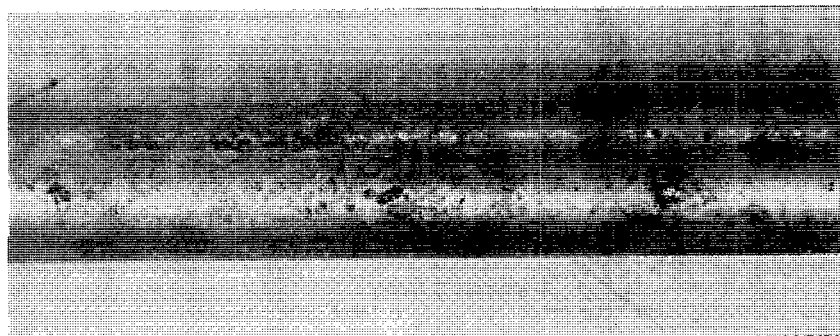
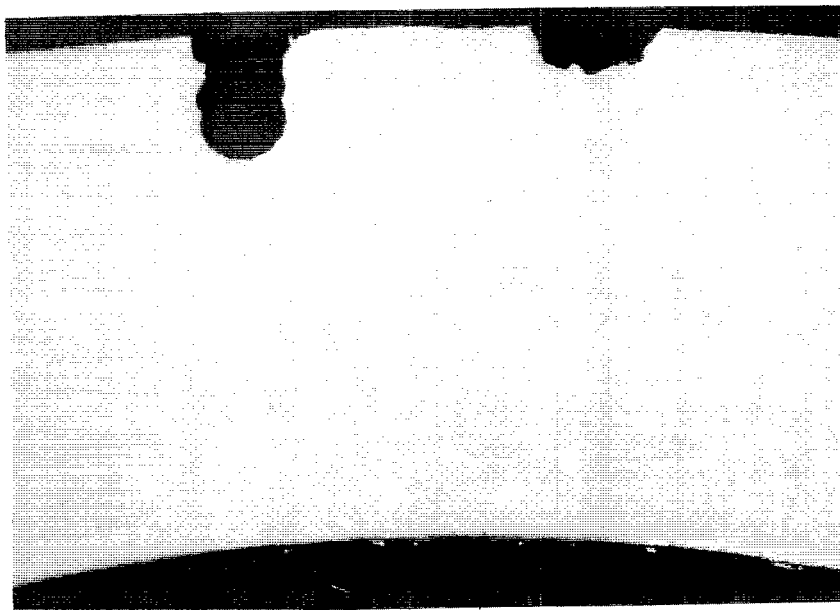
Figure 13. Surface Characteristics and Pit Depth of Type 347 Exposure Sample

Exposed Portion

Sheltered Portion

Cross-Section of Tubing Wall in Deepest Pit Area

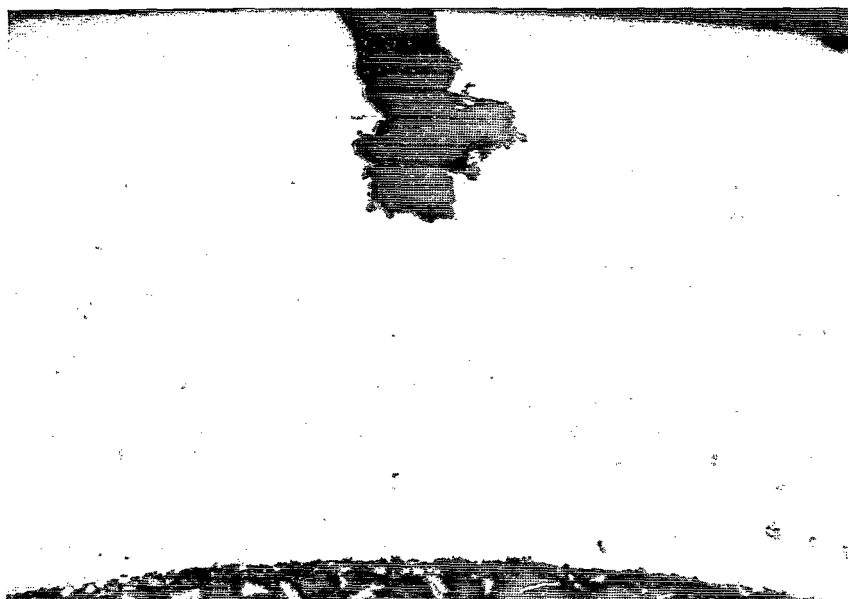
Figure 14. Surface Characteristics and Pit Depth of Type 304 1/8-Hard Exposure Sample

Exposed Portion

Sheltered Portion

Cross-Section of Tubing Wall in Deepest Pit Area

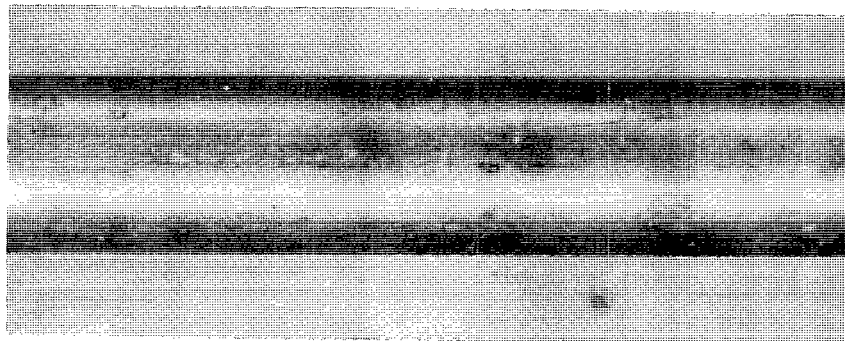
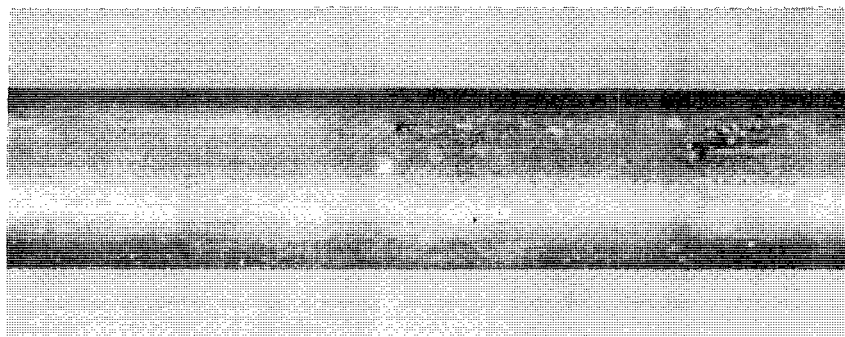
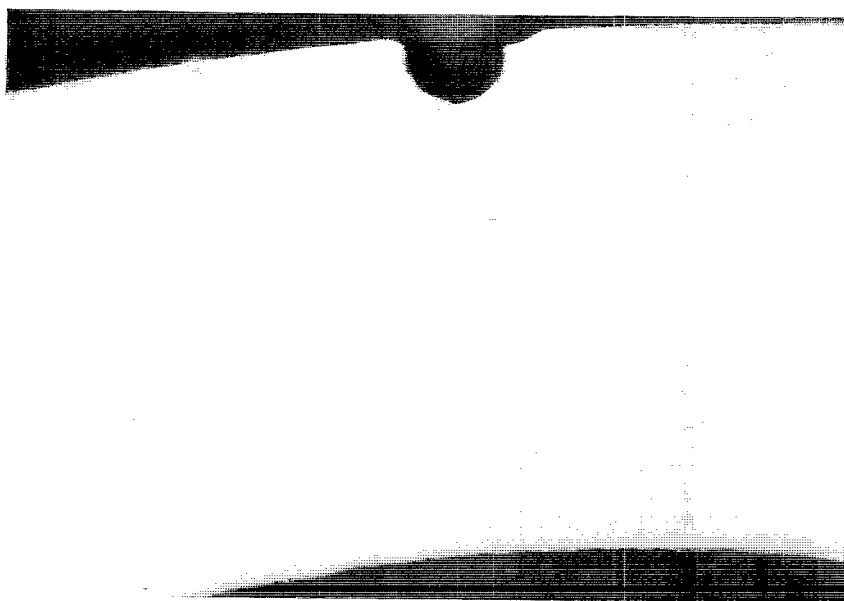
Figure 15. Surface Characteristics and Pit Depth of Type 316 (ASTM-A269) Exposure Sample

Exposed Portion

Sheltered Portion

Cross-Section of Tubing Wall in Deepest Pit Area

Actually, the deepest pits found to date in any of the samples have been in Type 316L and in the Type 316 (MSFC 10M01734), as is shown in Figures 11 and 18. This is not to suggest that Type 316 has a higher pitting rate than the other grades; in another Type 316 sample (Figure 15), no deep pits were found. The evidence cited here does suggest that no single austenitic stainless steel of the grades tested in this program is significantly better than the others for the fluid-systems applications in an environment of the KSC type.

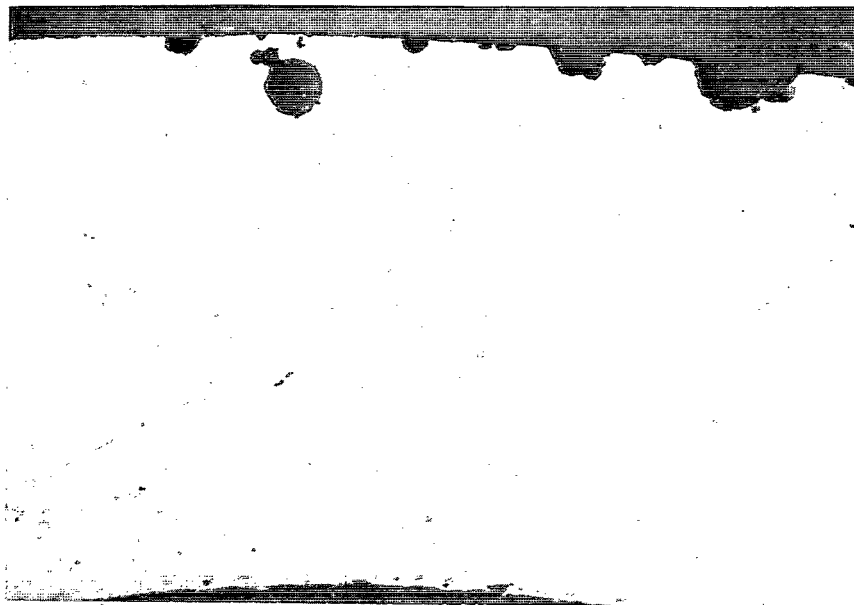
Figure 16. Surface Characteristics and Pit Depth of Type 321 Exposure Sample

Exposed Portion

Sheltered Portion

Cross-Section of Tubing Wall in Deepest Pit Area

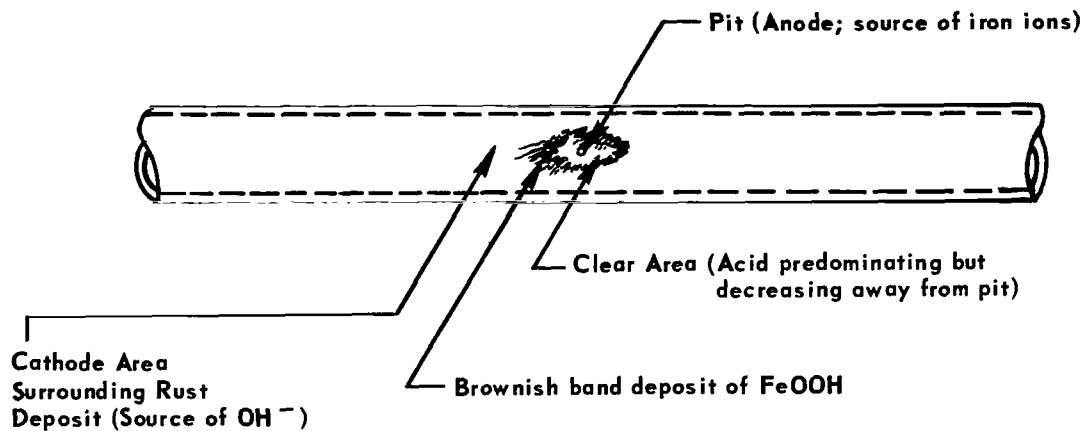
Figure 22. Surface of Tubing in Pit Area

For amplification of the previous references to the mechanisms of pitting corrosion, the following discussion is submitted. In pursuing these points, reference is made to Figures 22 and 23 which depict schematically the morphological and electrochemical conditions prevailing in the pitting corrosion of a section of stainless steel tubing. Figure 22 shows the tubing surface in the vicinity of an active pit, operating in a film of moisture in which there is a dissolved electrolyte. In the KSC area, this is usually sodium chloride, although various other compounds can serve as "solution-type" (ionic) conductors. Chloride ion, as pointed out by Fontana, (References 1 and 2) has the apparently unique ability to penetrate the normally protective complex oxide layer on the stainless steel to cause pitting initiation. In the absence of the chloride ion, pitting is usually initiated at points where mechanical breakage of the oxide layer has occurred, or at non-metallic inclusions present at the metal surface.

Pitting, once initiated, usually continues whenever moisture is available (whether from condensation, salt fog, or other source). The center of the site, the pit itself, is the anode, within which are generated iron ions (ultimately Fe^{+++}) and hydrogen ions (H^+). At some distance from the pit but in the moisture film, is located the cathodic site which is a relatively large area of the unbroken oxide layer on the tubing surface. With this condition, there is a large driving force for enlargement of the pit, since the limiting factor in the electrochemical current generated by the cell is the area of the anode. The cell potential for the pitting of stainless steel is of the order of 0.7 volt. This type of electrochemical activity is called an "active-passive" cell. Hydroxide ions (OH^-) generated in the cathodic area surrounding the pit, and iron ions generated in the pit migrate toward the opposite electrodes and meet in a ring-shaped area around the pit. In this area, the brownish corrosion product identified many times by X-ray diffraction analyses as consisting mainly of iron oxyhydroxide (FeOOH), is deposited on the stainless steel surface. Figure 23 shows the same basic pitting mechanism occurring in a cross-sectional view of the tubing wall. It should be noted that hydrogen ions tend to accumulate within the pit itself, so that the pH may commonly be of the order of 1.
